# Petrochemical Industry

## CASE STUDY

| Category | Investigation of Guide rod of U-bend in xylene heater |

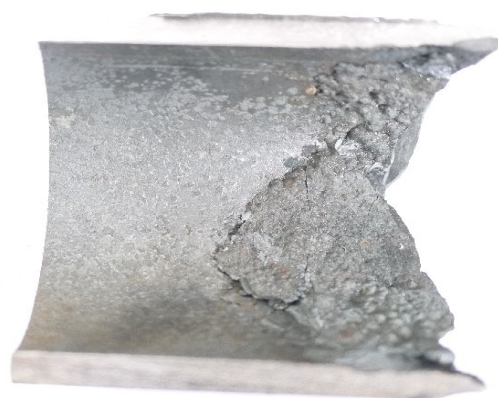
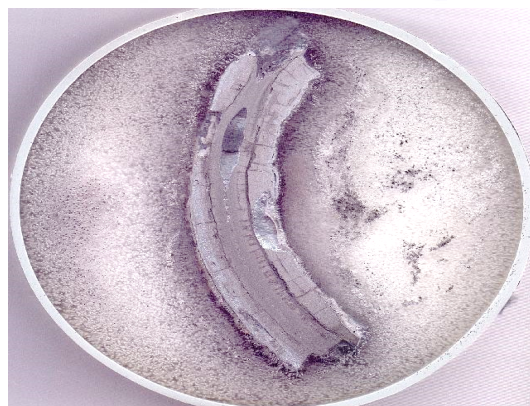
- Guide rod of U-bend in xylene heater, train-3, aromatics complex was found to have broken into two pieces during regular surveillance. The guide rods were found cracked on the U tube bends.
- Initially around 3 guide rods were found detached from the U-bend. However, after cleaning of the heater tubes, 7 more guide rods were found broken.
- The xylene heater was commissioned in the year 1999 and failure was noticed in September 2015. The service life of the failed guide rod is around 15 years. MOC of the guide rod is SA 304. There is only one guide rod for single U-bend.

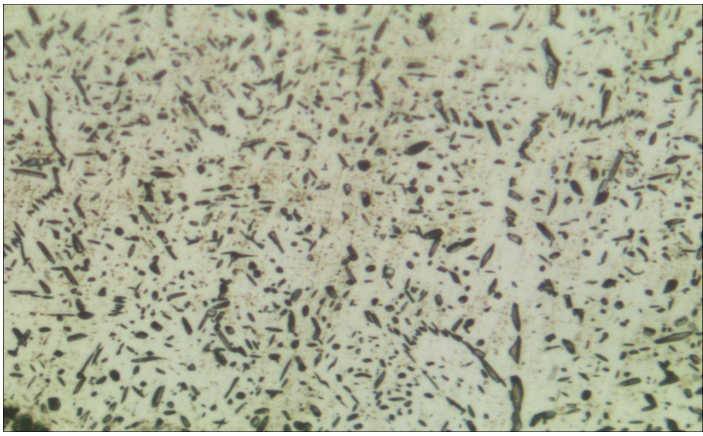
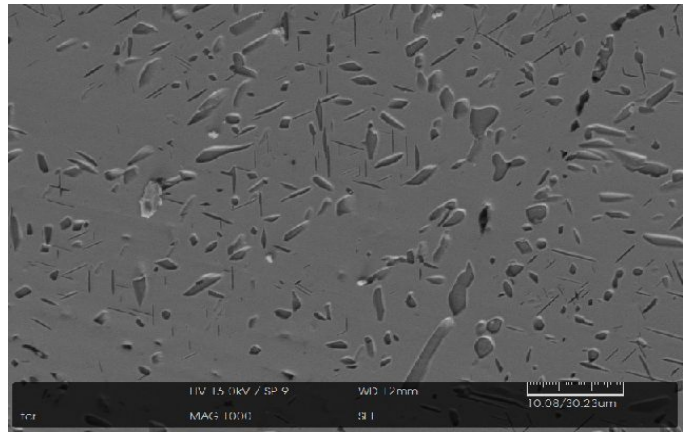
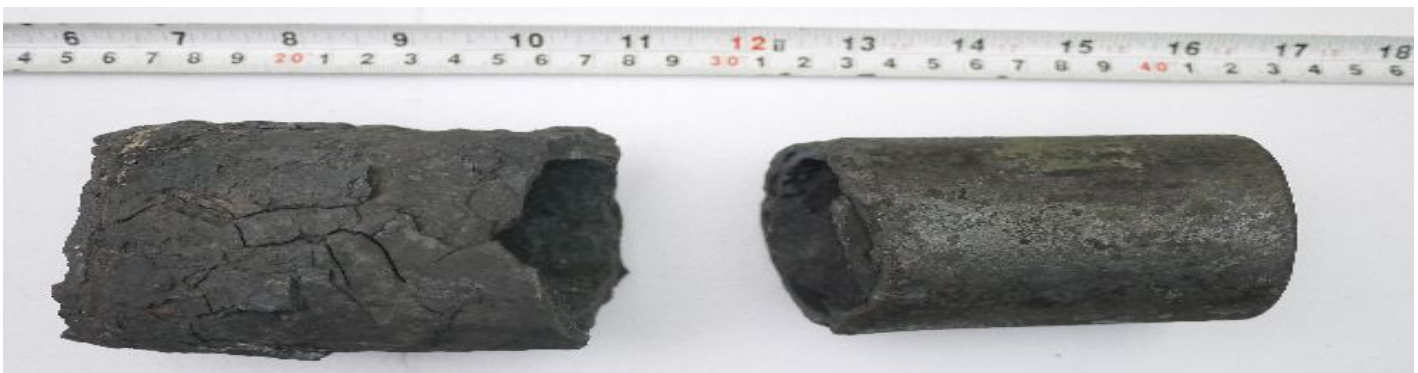
- The guide rod metallurgy in terms of MOC, microstructure and hardness values appear to be normal.
- Extensive scale formation on both OD and ID along with the significant sigma phase formation is noticed on the damaged portion of the guide rod.
- The guide rod failure by breaking into two pieces is because the damaged portion getting exposed to a temperature level of 870-950°C and it got detached from the other part due to sigma phase formation that rendered the material brittle.

- While the temperature conditions inside the U-bend are not exceeding 300°C, the guide rod exposure to such a high temperature level needs to be deliberated from the heat transfer conditions, flame impingement due to improper functioning of the burner or any other related reason.
- Use of 310 alloy will improve the life of the guided U bend.
