# Petrochemical Industry

## CASE STUDY

Category Investigation of Hot header in Reformer

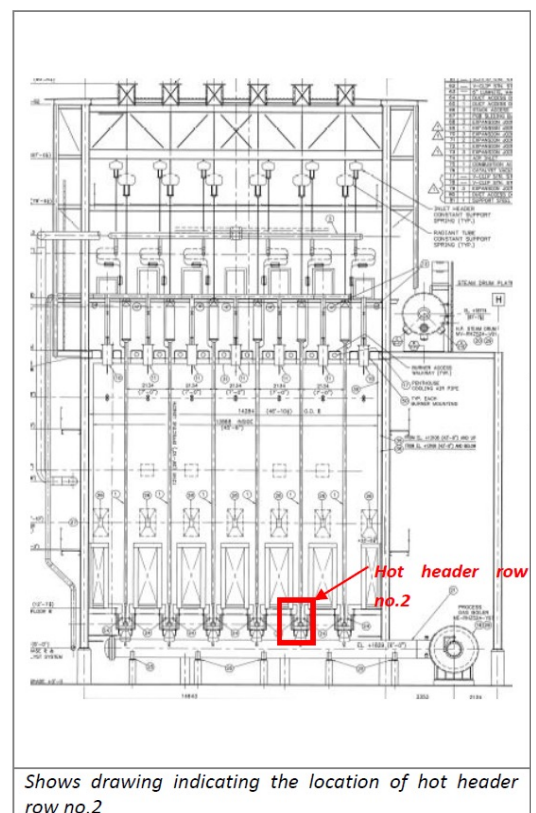
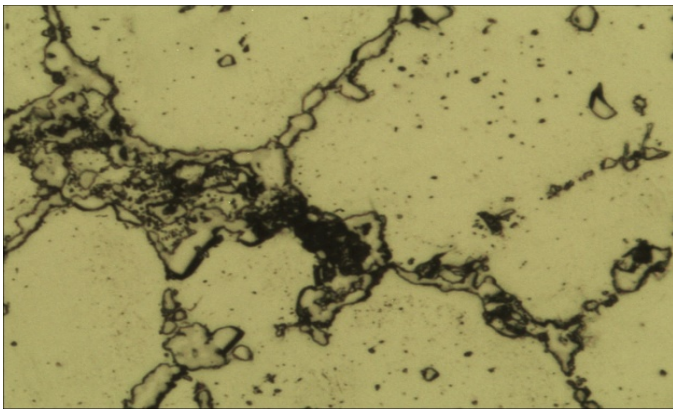
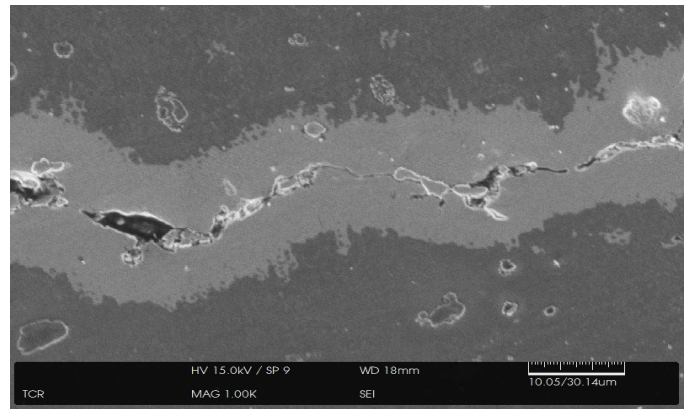
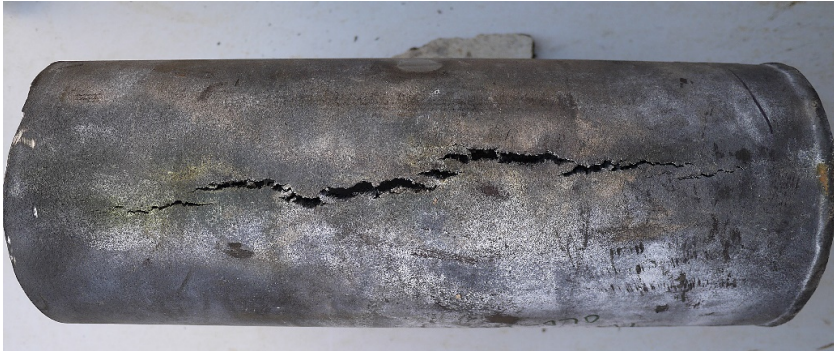
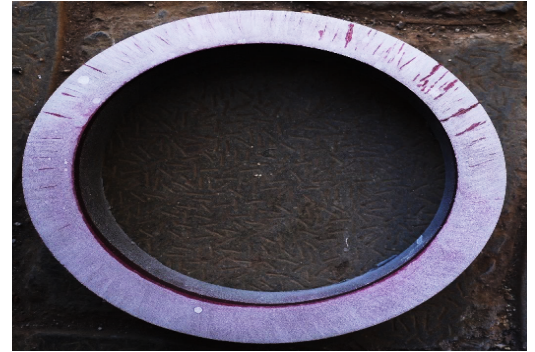
- Failure of 2nd row hot-header of Hydrogen production unit occurred. On inspection, crack was observed between weldolets 94 and 96.
- The failure was noticed through rising trend of one of the temperature transmitter of flue gas temperature placed at exit of the reformer.
- This was confirmed by detection of hot spot at south end, 2nd row hot header along with paint peel off on panel covers.

- On inspection, multiple cracks were noticed at 6'o clock position of around 400mm.
- Nature of failure indicates mid-wall fissure development and damage in terms of creep.
- About 2% creep strain is observed at areas where no (OD) surface detectable cracks.
- The failure of the hot header is essentially because of the creep indicating ageing in view of prolonged high temperature exposure which resulted as rupture in form of longitudinal cracking.

- Rest of the headers shall be checked by radiography, DP and in-situ microstructural examinations to detect presence of creep voids/fissures.
- Ultrasonic attenuation measurement may be carried out at available opportunity on all headers to ascertain the possibility of onset of creep damage.
- All other headers need to be checked with diameter measurements and creep strain in excess of 2% may be subjected to destructive remaining life assessment.
- Reason for any prolonged temperature excursion requires to be deliberated from furnace design and process point of view to increase the life of new headers.
