## EPC Industry

### CASE STUDY

Category Investigation on Bevel Helical Gear Box

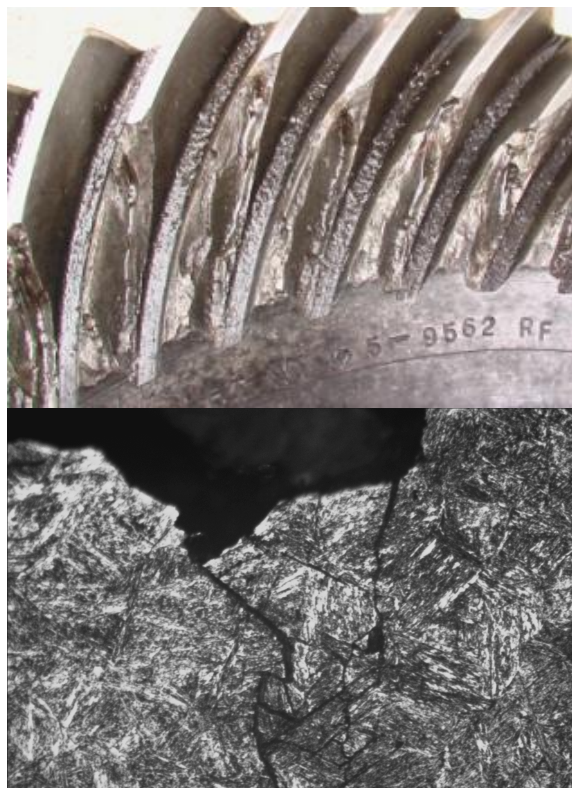
- Bevel wheel and intermediate helical shaft of gear box was failed prematurely during its service.
- 11 gear boxes out of 22 were damaged which were replaced, after working for 100-500 hours similar failure occurred.

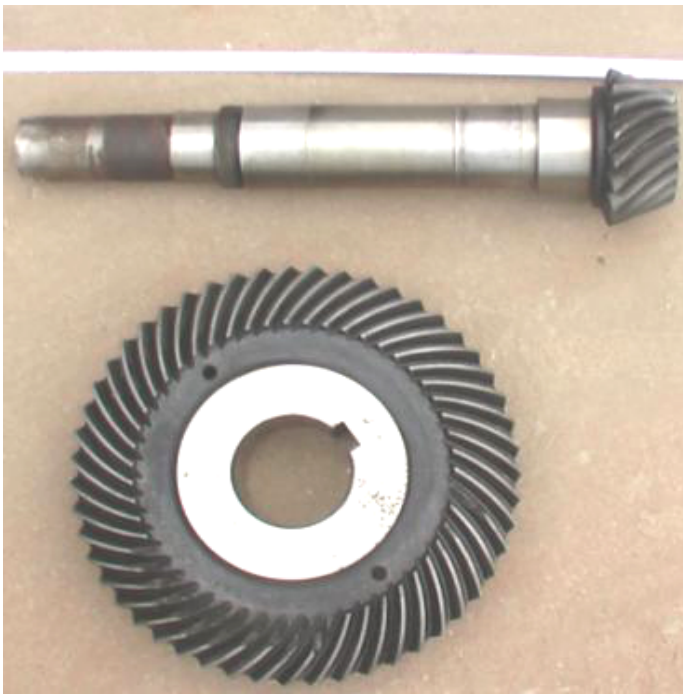
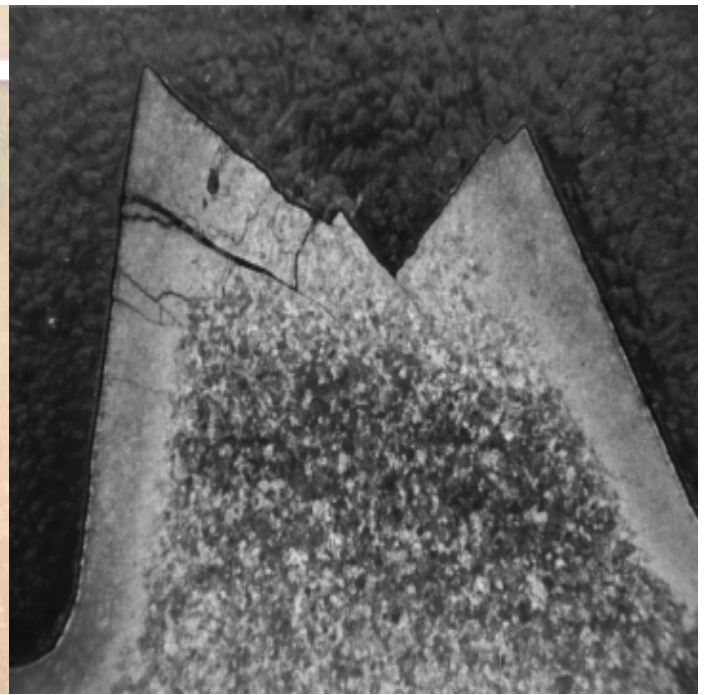
- The principle reason for the premature failure of the bevel gear wheel and pinion shaft is the uneven case depth obtained during case carburizing treatment.
- The failure has been assisted further hardenability, poor hot working practice and faulty oil hardening and tempering heat treatment

- Case carburizing treatment should achieve uniform case depth as per design stipulation. It should ensure freedom from any grain boundary carbides.
  - Hardening and tempering done should achieve tempered martensite into the case. Core microstructure should be bainite and tempered martensite, free from traces of ferrite to ensure higher toughness.
  - The selection of the material is based on the hardenability consideration and not merely on the chemical composition.
  - Material stock should not be from induction melting con-cast route, it should be at least EAF + LRF route. Vacuum degassed material is highly preferable.
  - The hot working should be done in such a way that the prior as cast structure is completely destroyed with proper reduction ratio. Upset forging requires to be carried out to prevent cutting of flow lines at the teeth edges.
-
