## EPC Industry

### CASE STUDY

Category Investigation on 4" equal tee

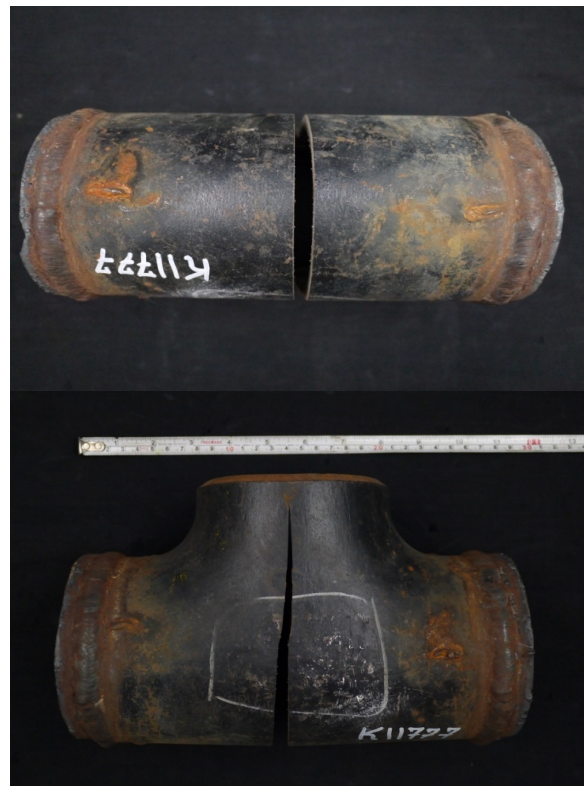
- 4" dia. equal Tee was found to have cracked from the middle portion, after a day from the completion of welding.
- Prior to welding DP test had been carried on bevel ends and branch area of tee and defects were not found.
- the tee was found to develop crack on belly portion next day even though the precautions were taken.
- The MOC of the Tee is ASTM A234 WPB, and it has been normalised at 920 deg. C

- The tee should undergo WFMPI to ensure freedom from crack like defects.
- Prior to cold working the pipe should undergo proper annealing treatment and ID surface should be free from adherent scale.
- In-situ metallography requires to be carried out to ensure proper normalizing treatment done to the tee on sampling basis.

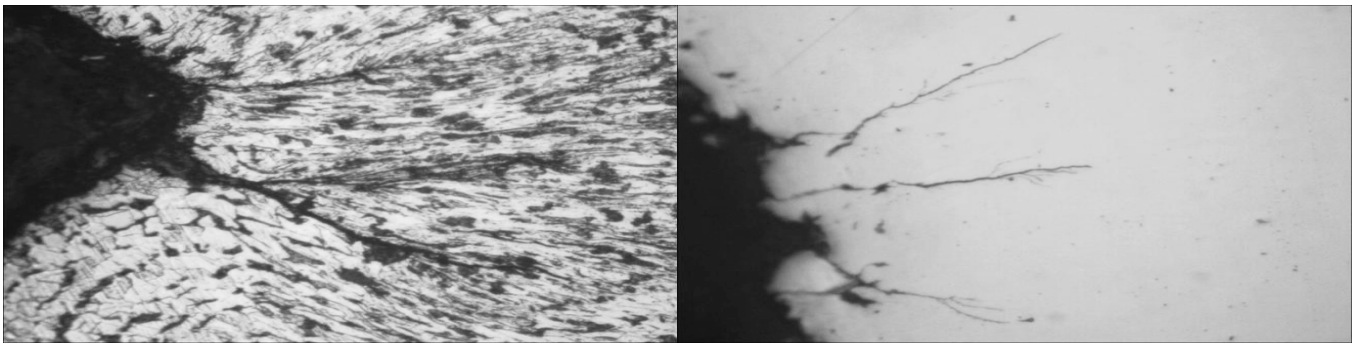
- Premature failure of tee after welding is on account of presence of intrinsic defects like oxide scale entrapment and hairline cracks on ID as well as OD surface.
- The improper cold forming operation in absence of prior annealing treatment of the pipe, along with the poor post normalizing treatment of the Tee has retained the deformed structure.
- Overall it rendered the tee susceptible to cracking under influence of welding stresses as well as possibility of stress while handling the assembly.

| Elements | Composition by weight per cent |
| Oxygen | 27.76 |
| Silicon | 1.87 |
| Iron | 70.37 |
