# Fabrication Industry

## CASE STUDY

Category Failure Investigation of Tubular Tower Base Flange

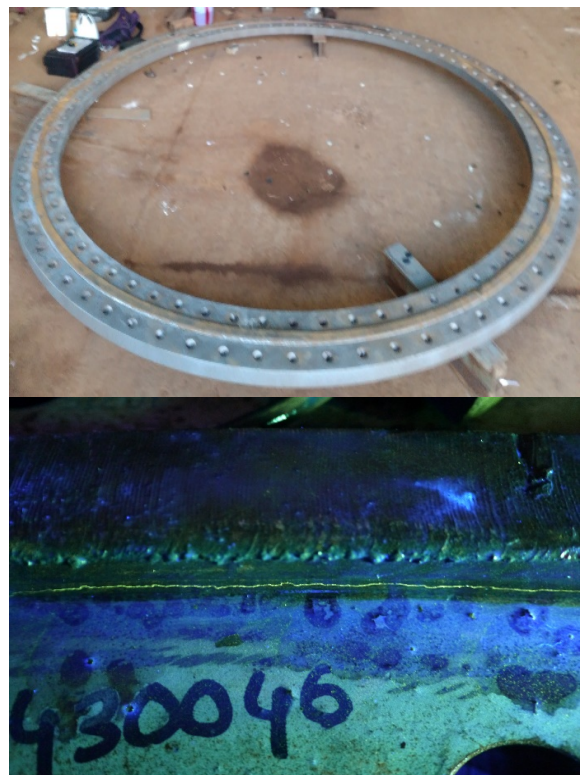
- The base flange of vertical wind mill tower structure failed by way of cracking.
- The failure was noticed after welding base flange with shell of bottom section.
- Crack was seen on the inner side of weld neck radius of flange at the flange side toe of the weld.
- MOC of flange is S355NL Z35

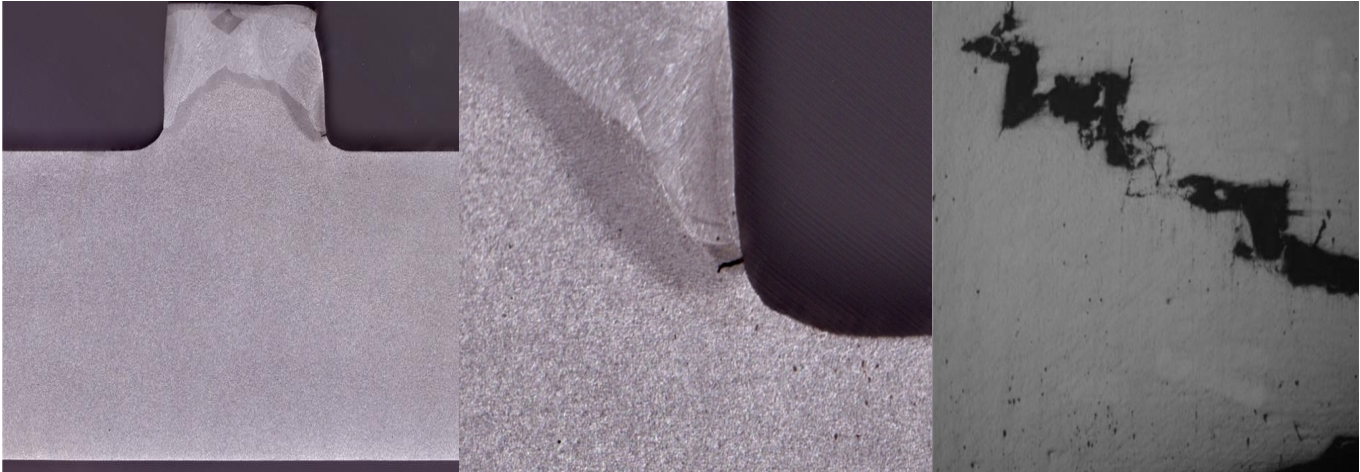
- The cracking seen on the flange HAZ region is because of damage mechanism referred as 'delayed cracking' caused by high hydrogen level in the weld region. The most likely source of hydrogen can be from the flux.
- The hydrogen content in weld pool is to the tune of 22ppm which is excessively high

| Locations | Measured Hydrogen |
| Parent metal | 2 ± 0.25 ppm |
| Weld | 21.50 ± 2 ppm |

- Both flange and weld metallurgy in terms of MOC, microstructure and mechanical properties is satisfactory.
- The cracking is noticed precisely in heat affected zone (HAZ) on the flange with inter-granular tendency.
- Care requires to be taken to prevent moisture ingress at the time of SAW. The flux used required to be properly dried.
- Appropriate preheating and PWHT would mitigate the problem of higher level of hardness in HAZ region. This is very important for long term integrity of weld joint.
