# Fabrication Industry

## CASE STUDY

Category      Investigation of Bearing rings.

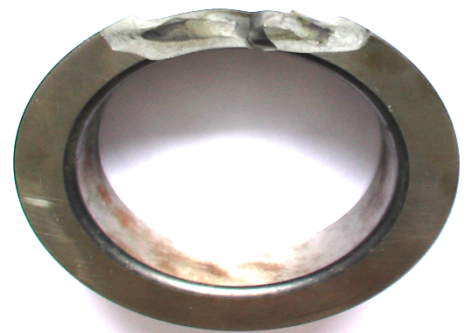
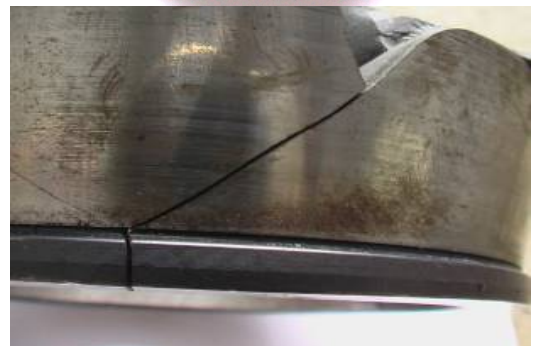
- 683 inner ring having identification no. ABC/F/01 started showing cracks during grinding operation, resulting into outright rejection, in taper bearing plant.
- Cracking is confined to about 0.1% of the rings that are manufactured. About 60 nos. are found cracking in a lot of 6 thousand pieces.
- The MOC is SAE-52100 ball bearing steel.

- Slight improvement in the spheroidizing annealing cycle is recommended to eliminate elongated massive nature of grain boundary carbides.
- Recommended to check the heat treatment aspect for receiving uniform heat.

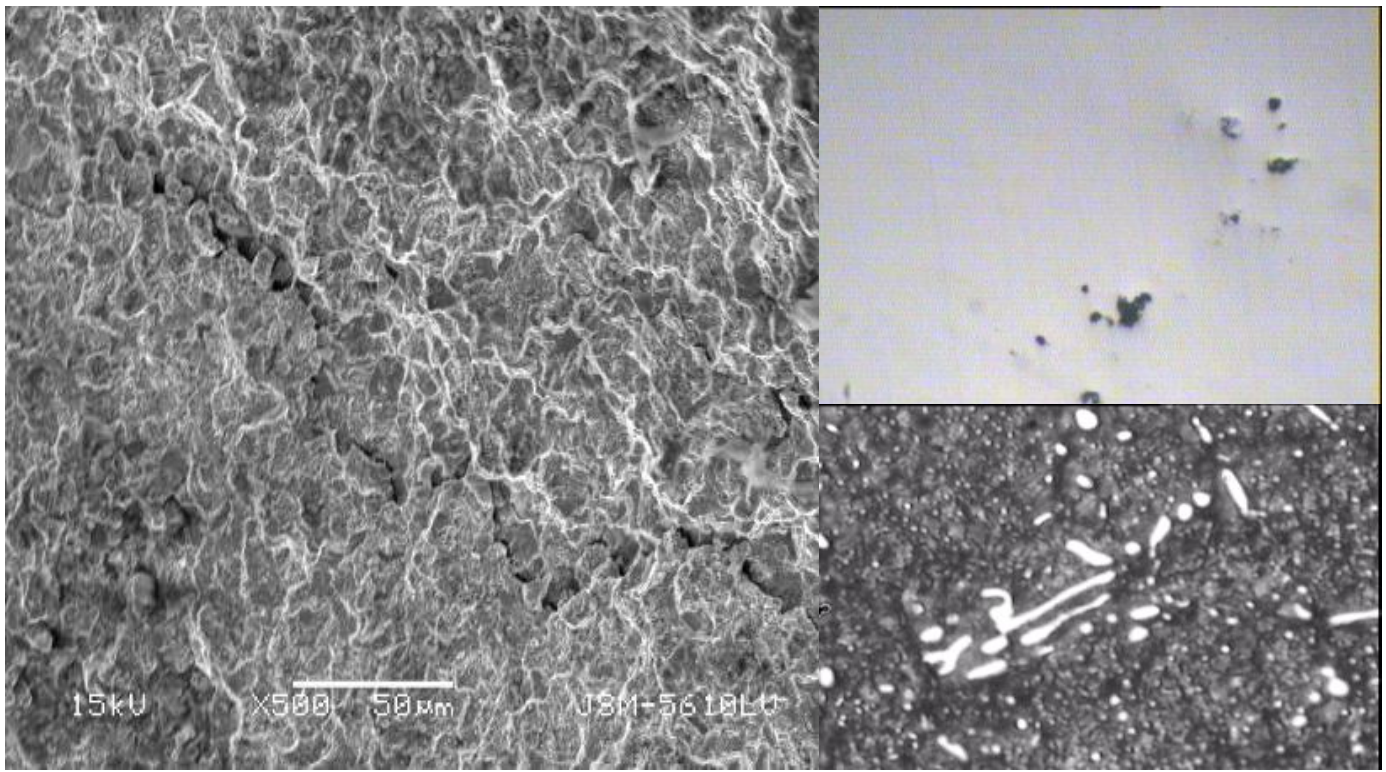
- Cracking of the rings during grinding are predominately attributed to cumulative effect of subtle deviations in the carbide distribution, inclusions and heat treatment process variables.
