# Manufacturing Industry

## CASE STUDY

Category Investigation of 3" Equal TEE

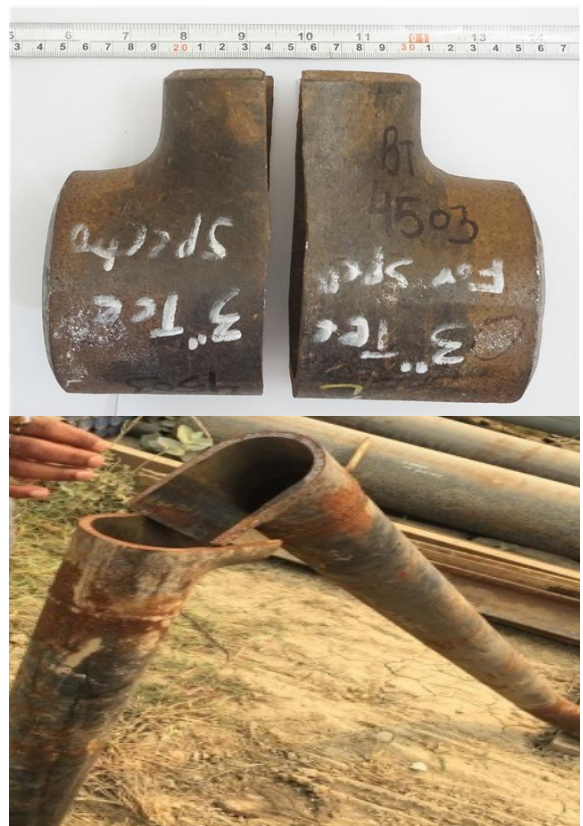
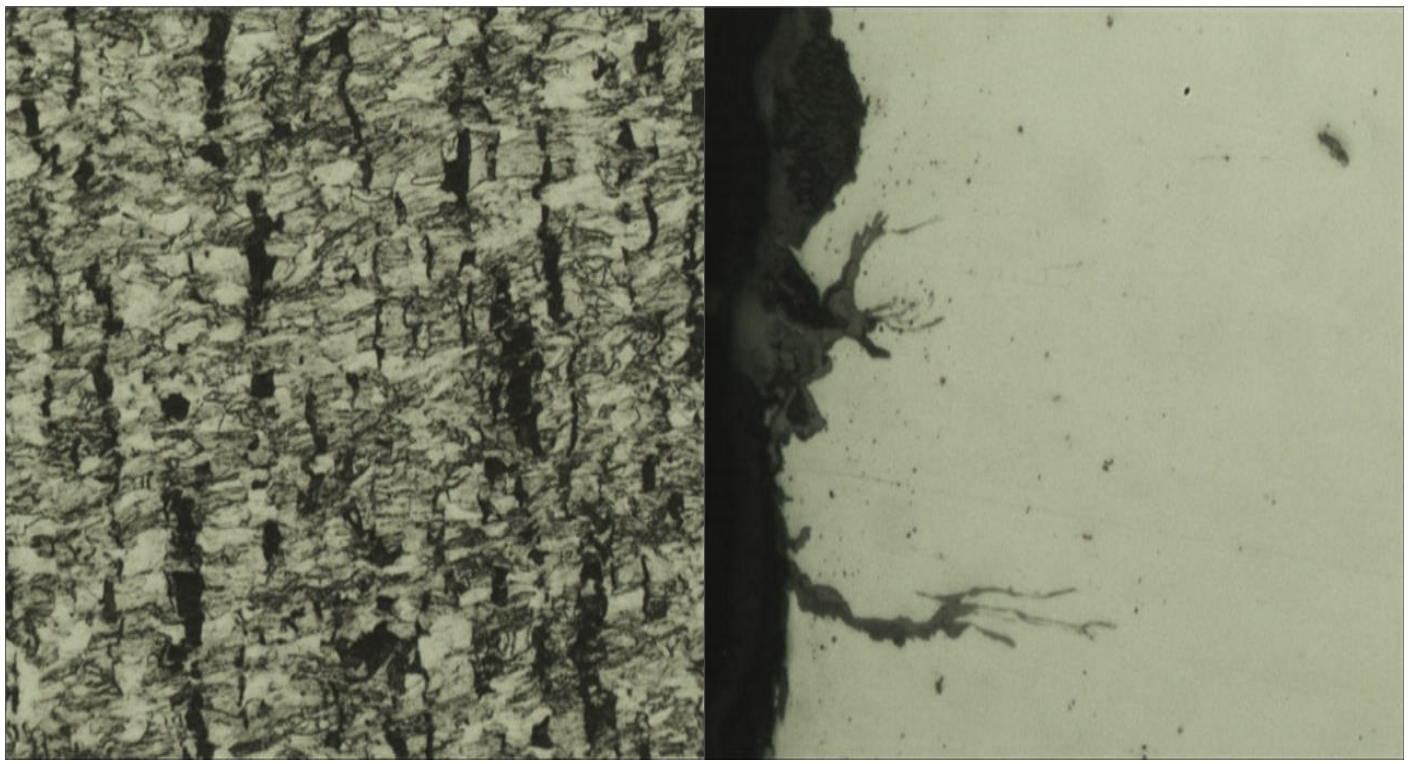
- 3" equal tee of heat cracked into two pieces while lifting during installation.
- MOC of the tee is ASTM A 234 grade WPB

- The tee failure is under the combined influence of cold worked condition and scale entrapment from raw material stage leading to brittle failure.
- The metallurgical condition barring MOC is not satisfactory.

- The crack initiation leading to breakage appears to be from the edges where entrapped scale acted as stress concentration site.
- The tee microstructure indicates heavy cold worked condition.
- The raw material before tee forming should undergo proper NDT to ensure freedom from any scale entrapment.
- The raw material of tee should be in properly heat treated condition and also should undergo normalizing heat treatment after cold forming as per the specified requirement.
