# Oil and Gas Industry

## CASE STUDY

| Category | Investigation of Jaw Pins on Tong |

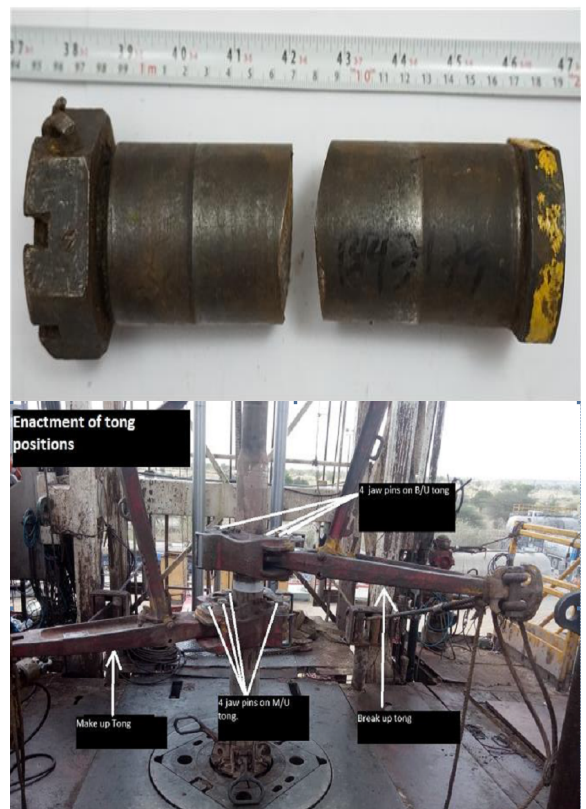
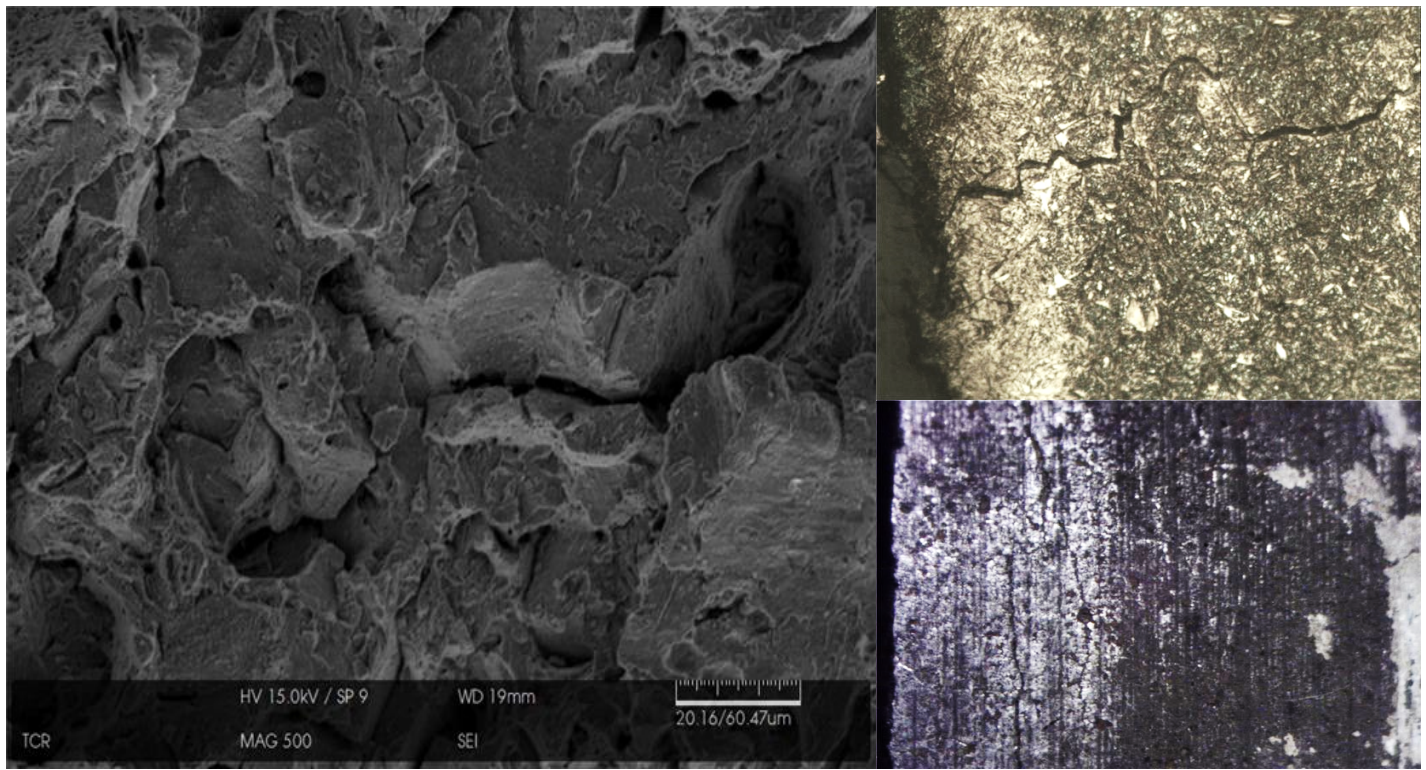
- Jaw pins of M/U tong failed by way of fracture after about one year of service.
- The failure was noticed when unusual breaking sound was heard by driller.
- Jaw pin from break out tong was found broken and also one more jaw pin from the make-up tong was found broken.

- The tong pin failure is because of untampered martensite remaining present in the hardened case and having propensity for in-situ brittle cracking under operation.
- MOC of pin matches with AISI 4140. Hardness values are higher at edge. Impact results indicate poor toughness.

- Intergranular cracks are observed at the surface hardened zone.
- Microstructure of surface hardening zone is untampered martensite.
- The pin should be having good toughness of around 15 Joules with higher hardness. The properties selection shall be done as per the operational requirement in consultation with design expert.
- The pins should undergo multiple tempering treatments to transform all the untampered martensite into tempered martensite and epsilon carbide to avoid any cracking.
- All the incoming tong pins should undergo hardness test along with WFMPI (wet fluorescent magnetic particle inspection).
