# Oil and Gas Industry

## CASE STUDY

| Category | Investigation of 14"PC riser line |

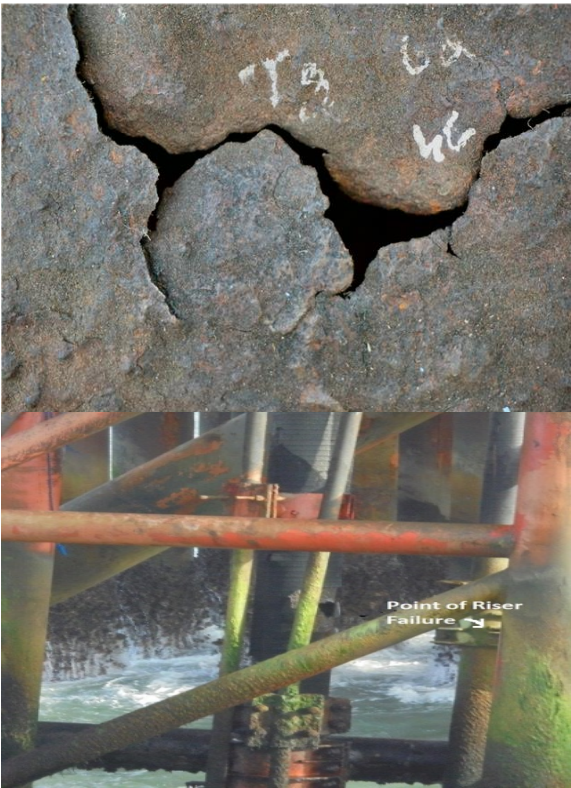
- 14" PC riser in line leaked at the splash zone after 20 years of service life.
- The leak was noticed during an unplanned shutdown activity when a gas cloud was observed at the PC platform and PC riser pressure started decreasing.
- MOC of the line is API 5L X52 with neoprene coating on external surface

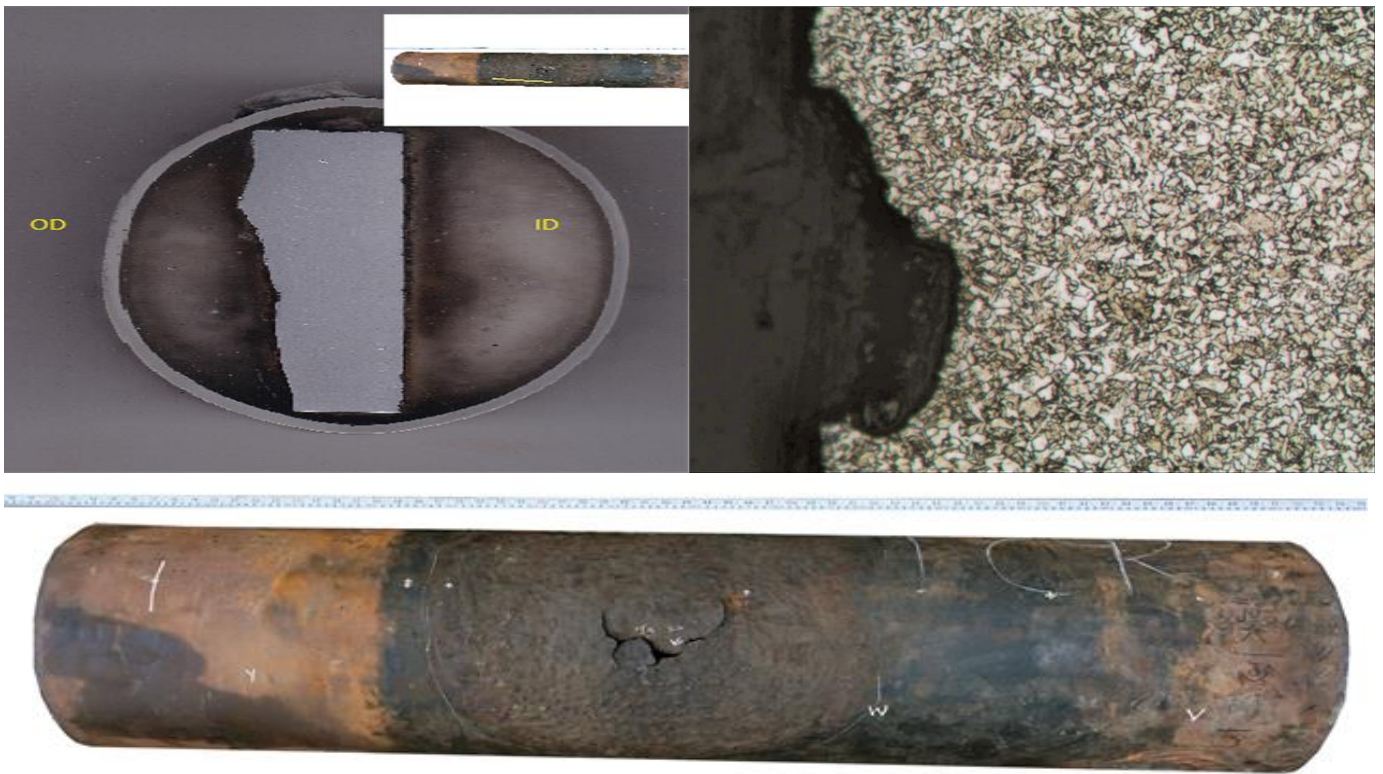
- The production tubing was punctured due to pitting corrosion mechanism attributed either due to CO2 corrosion during shut-in period or possibly because of use of contaminated/acidic CaCl2 solution.

- The riser pipe metallurgy in terms of MOC, microstructure and mechanical properties is normal.
- Localized thinning is observed only from external surface at the face of pipe having through and through opening.
- Damaged coating condition seems to have prevailed as thinning is seen only in localized area from external surface.
- Periodic visual inspection of piping would provide early detection of damage to the coating and corrective action may be initiated accordingly.
- The affected areas of damaged coating of pipe need corrective action.
