# Oil and Gas Industry

## CASE STUDY

Category Investigation of 10" Subsea Pipeline from Satellite Platform

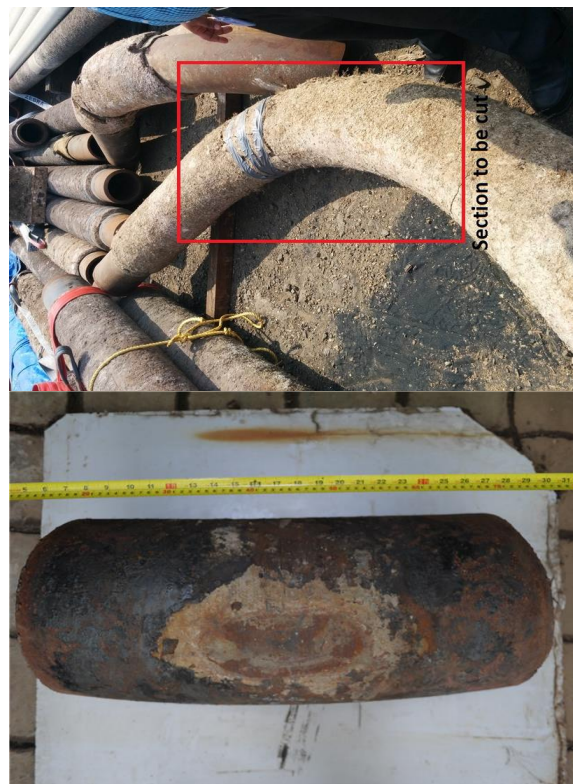
- 10" subsea pipeline transporting crude oil from satellite platform PE to PA was found touching the jacket structure at the J-tube location.
- Damage to the pipeline at the bend portion was suspected by way of thickness reduction.
- MOC of the pipeline is API 5L Gr.X65

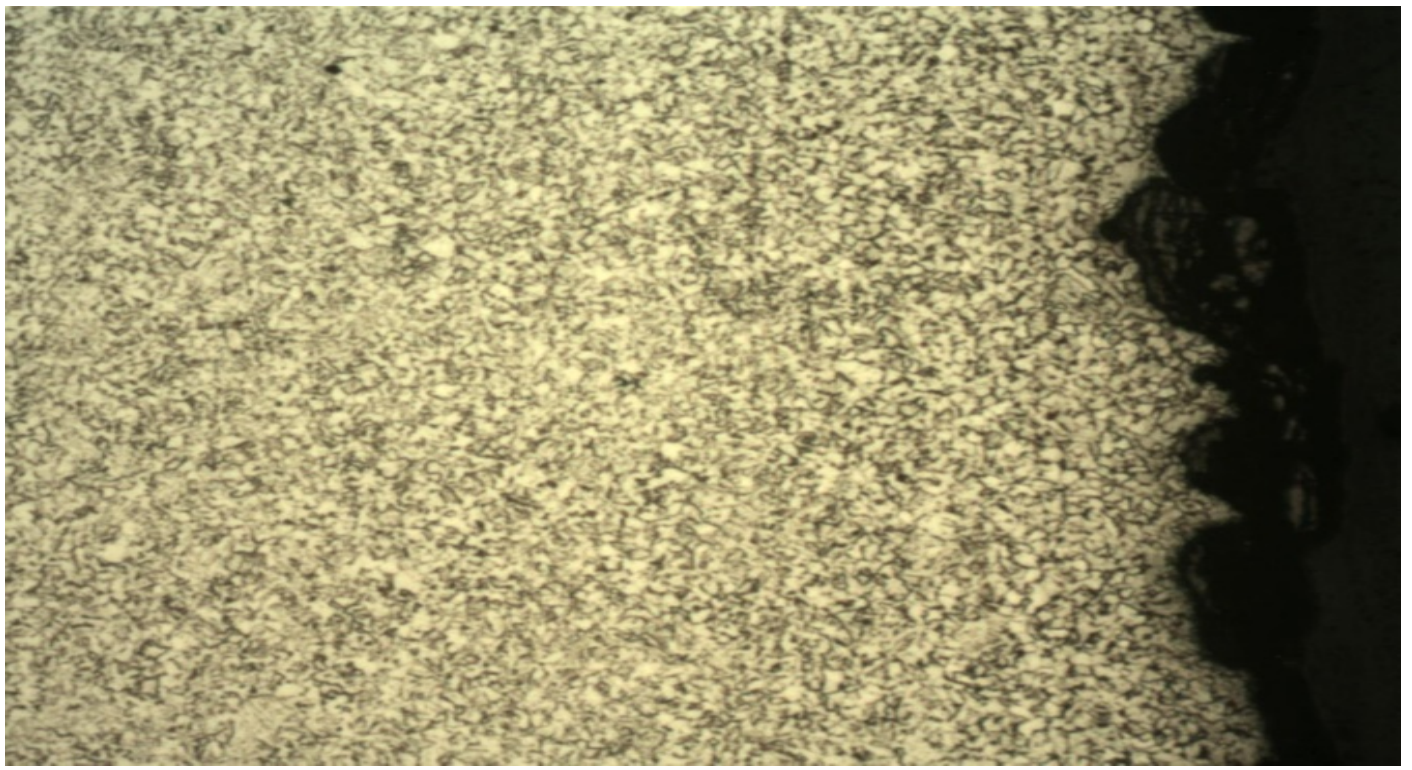
- All over the bend, extrados area shows lower thickness than the nominal thickness which appears due to bend formation.

- The pipe material meets with the intended specification of API 5L Grade X65.
- No significant presence of localized corrosion on OD as well as ID of extrados region.
- The damage in form of 0.3mm thickness loss in extrados region is superficial in nature at the elliptical patch area due to under-deposit corrosion from ID.
- There is no significant damage as well as thickness loss due to external rubbing.
- All the bends across the pipeline required to be checked for thickness in extrados region; those lower thickness than permitted needs to be addressed appropriately.
