## Power Industry

### CASE STUDY

Category Investigation of Platen Reheater Tube

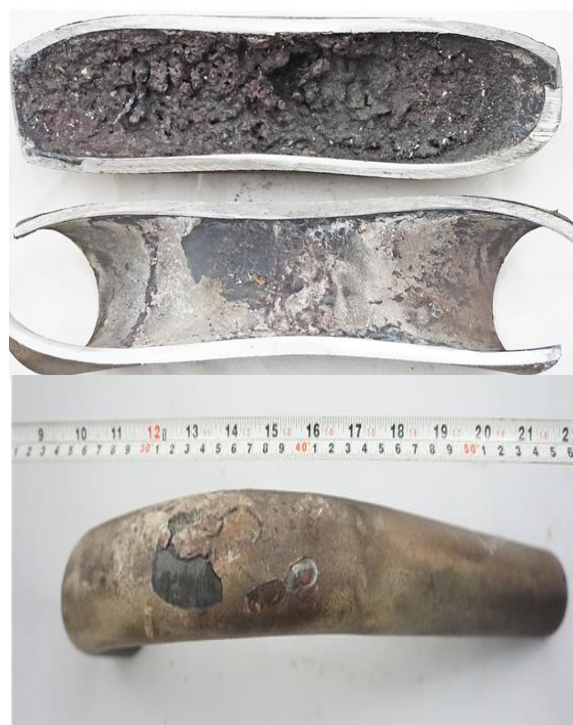
- Platen reheater tube failed in form of crack during service. Leakage was noticed as abnormal sound heard from peep hole of the furnace along with increase in consumption of DM water make-up.
- MOC of the tube is SA213 T22

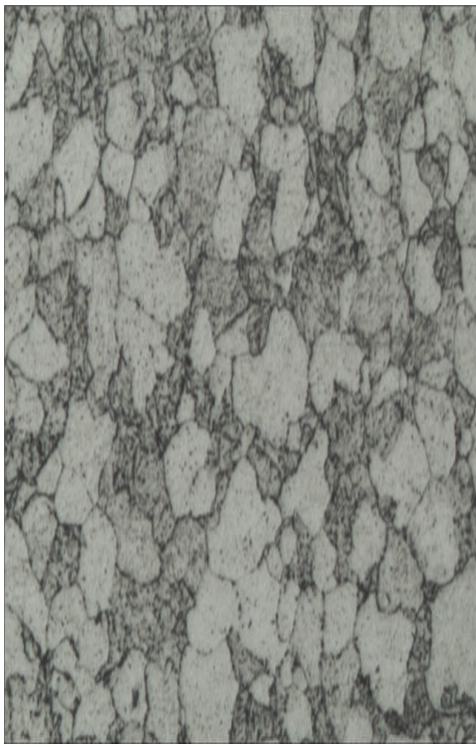
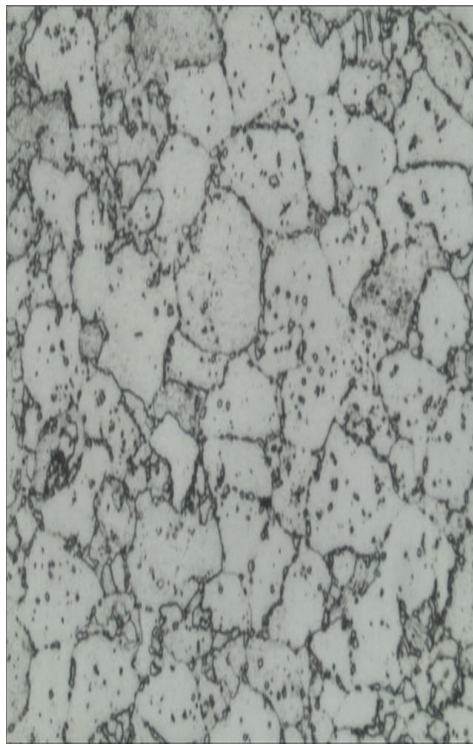
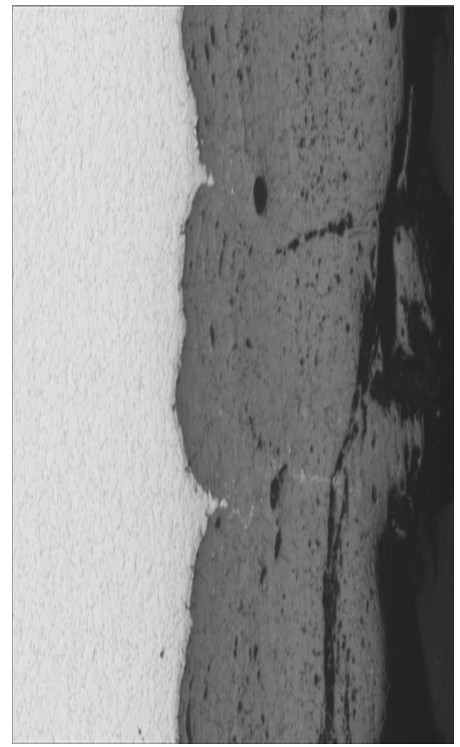
- The predominant damage mechanism leading to linear nature of puncture on extrados region of bend portion is because of the under-deposit corrosion promoted by carry over of water in the reheater and concomitant concentration of salt impurities.
- The metallurgy of reheater tube is as per the specification of SA 213 T22. While the tensile and hardness values appear to be satisfactory, the local microstructure degradation is because of the service damage.

- The thinning at extrados region towards leakage contours is mainly from inner surface where localized scale built-up has taken place.
- EDS analysis shows presence of sulphur, phosphorous and sodium ions along with moisture-based contaminations on ID surface near failure location. This points towards excessive scale formation in view of the persistent salt concentration and possible by presence of water at this location.
- Source of water ingress requires to be carefully explored and suitable remedial measures shall be taken and controlled.
